Old White Meeting House
320 US-2
South Hero, Vermont 05486

KAS #307230415

PRE-RENOVATION ASBESTOS INSPECTION REPORT

July 26, 2023

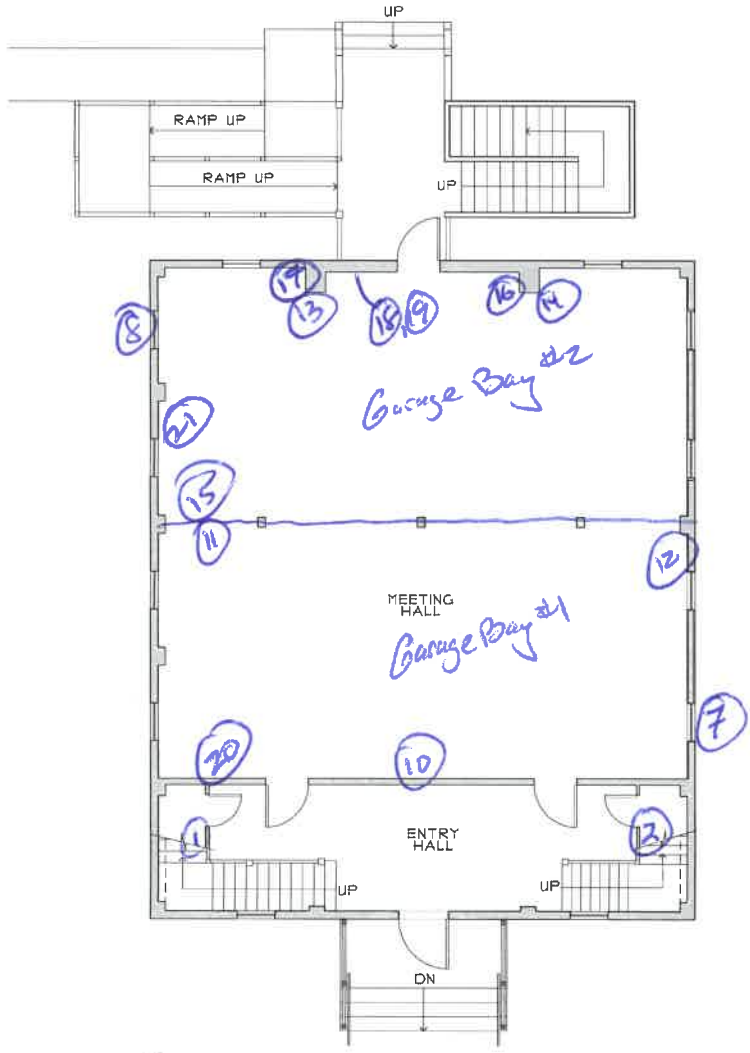
FIRST FLOOR PLAN
1/4" = 1'-0"

Building Plan with Sample Locations
