November 8, 2023

Re: Structural Engineering Assessment  
South Hero Town Office Building

EV # 23523

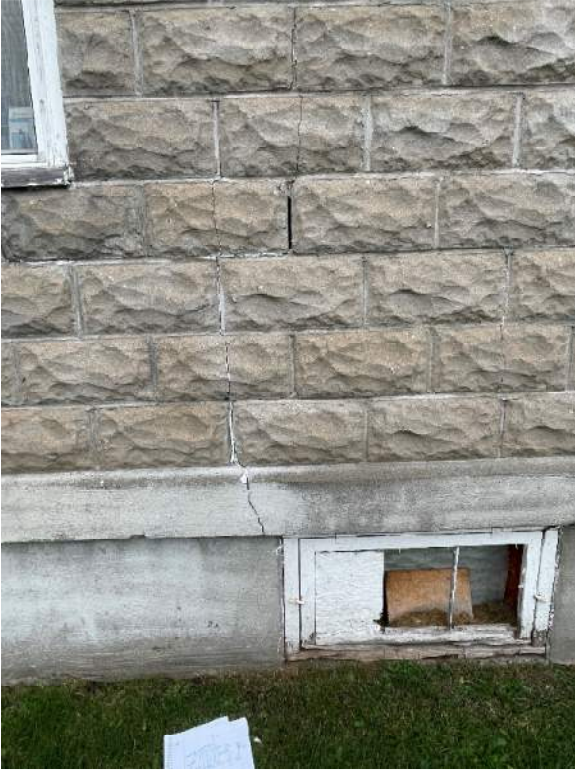
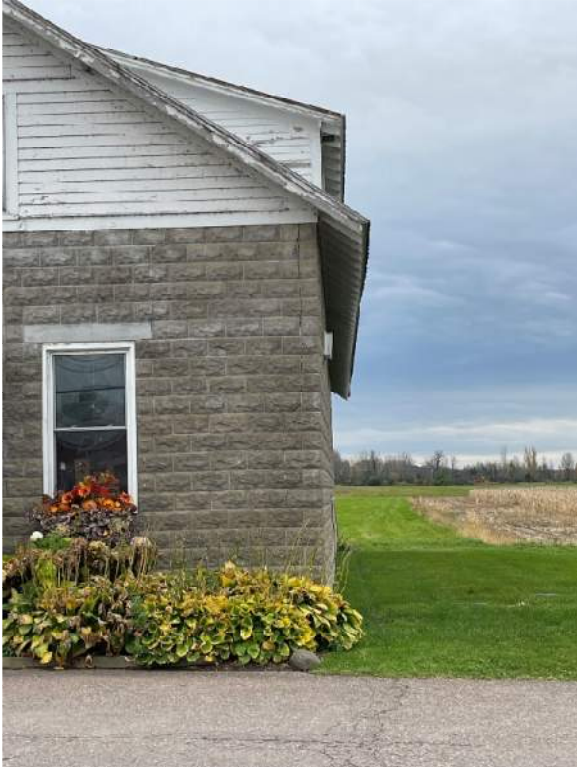
- There are numerous vertical cracks in the masonry. These are likely due to two causes:
  - Expansion and contraction: Walls tend to move with temperature and moisture changes. Buildings typically have vertical movement joints spaced about 15 feet apart to allow this kind of movement, but none are present here.

- Roof forces: The roof at the north section of the building is not horizontally restrained by wood ties and a horizontal load is placed on the masonry wall. This is likely causing the cracking at the building corners.

- In addition to vertical cracking, mortar joints are in poor condition and need to be repointed. Cracks left open are susceptible to moisture intrusion and further damage due to freeze-thaw cycles.

MASONRY CRACKING- NORTH AND WEST WALLS

- Reinforce roof framing to meet current codes. This will likely include sistering the existing rafters and adding a ridge beam at the north section.
- Repair the exterior masonry including repointing, replacement, and repair of cracks. Consider sealing the exterior and adding vertical control joints to control future cracking.

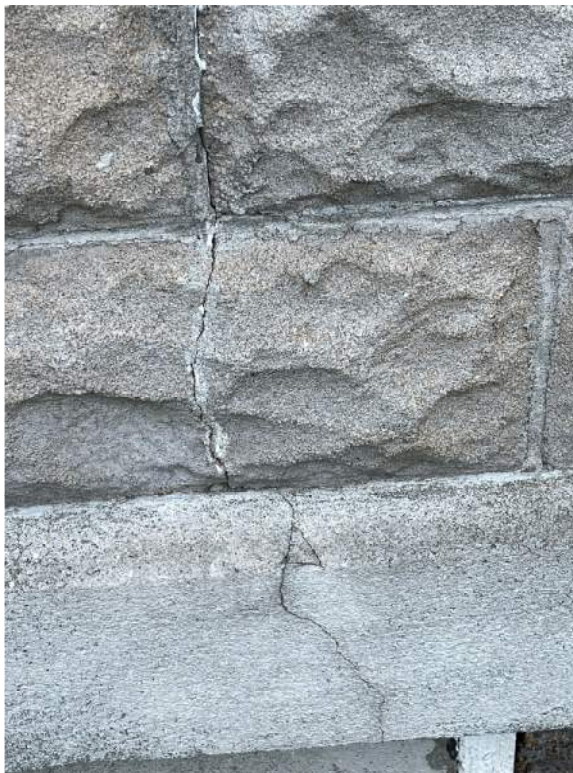
MASONRY CRACKING

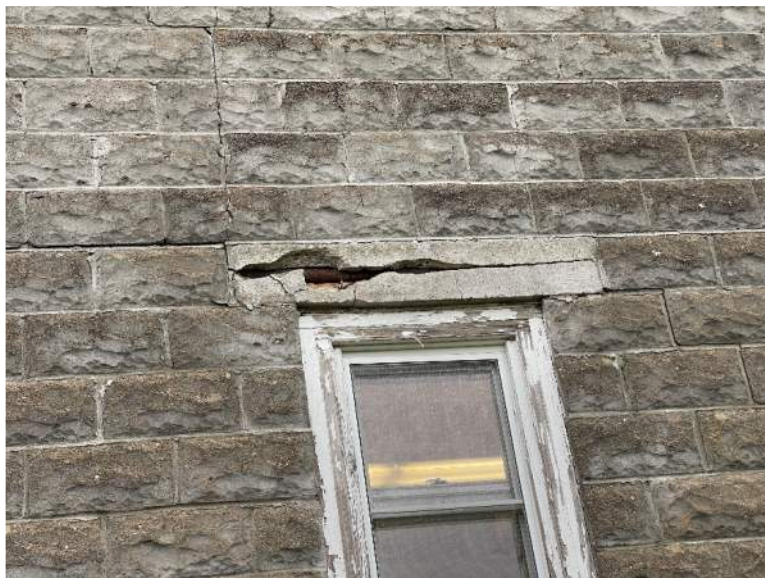
- Several of the lintels over the windows have deteriorated. One on the south wall should be replaced.
- The existing chimney is in poor condition, and it is understood that this is no longer in use. This should be considered for removal.

FAILING LINTEL AT SOUTH WALL

- Monitor snow load on the roof and clear the roof when there is more than 6" of heavy snow or 12" of light snow.
- Repoint the masonry joints and cracks that have developed.
- Replace the heavily deteriorated masonry lintel at the south.
- Avoid occupying the second floor.
- Conduct further evaluation of the main floor by cutting several access holes and investigating for rot or other structural damage.
- Repaint and repair all exterior woodwork.
- Follow recommendations of appropriate professionals for electrical, mechanical, life safety and air quality/mold issues. If possible, a poly vapor barrier could be added to the crawlspace floor.
- Continue with planning and implementing a deep renovation of this building or a move to a new building.

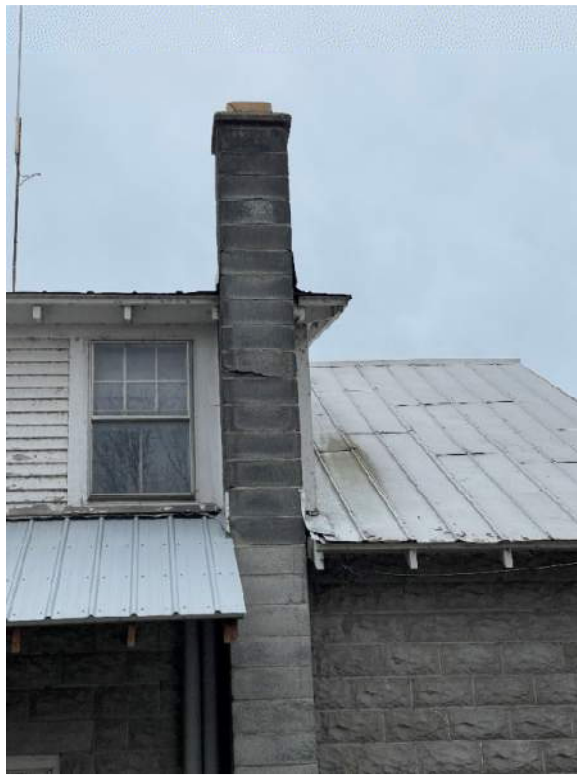
CHIMNEY DETERIORATION

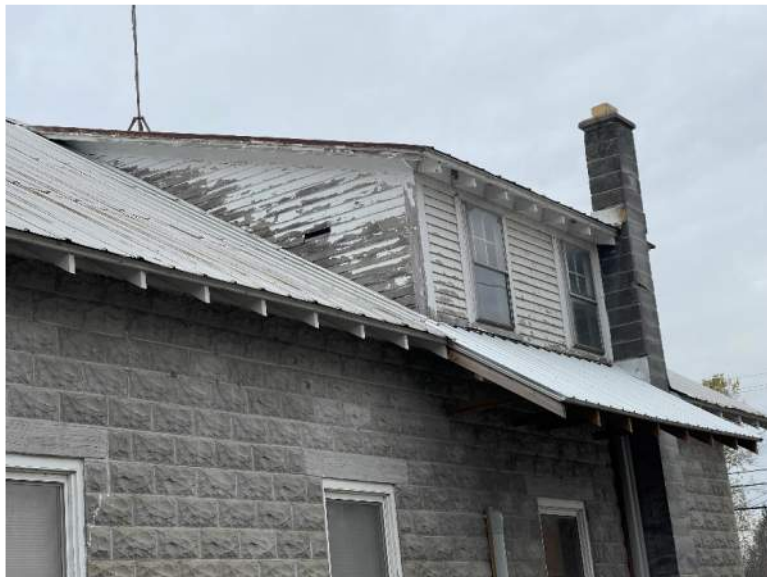
DORMER WOODWORK

Dormer: A shed dormer section is located between the north and south gable sections.

The dormer section is a stable configuration similar to the south section, but the shallower pitch of the roof negates the sliding snow effect, and this area would need to meet 40 psf requirements.

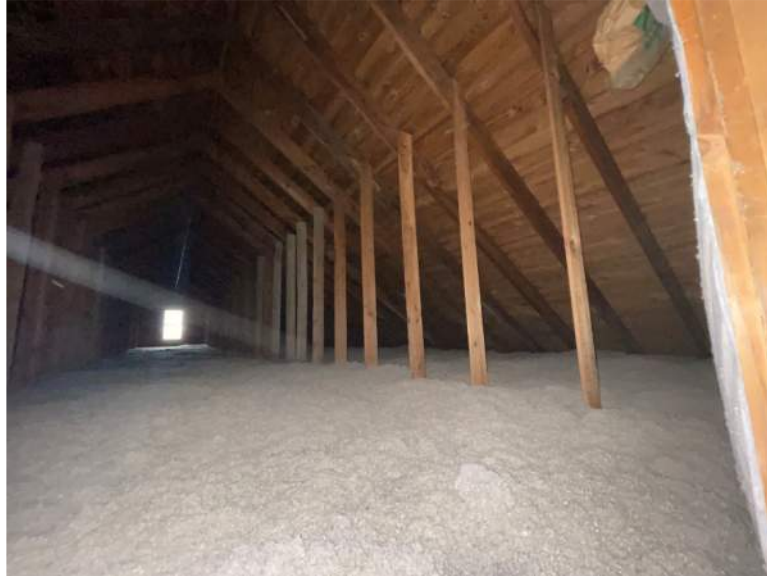
SOUTH SECTION ATTIC

South typical gable: The roof is framed of 2x8 rafters @ 24" spacing with a 1x ridge pole and ceiling joists that appear to be supported on the center wall in the offices below. A second ceiling has been added below the attic floor to reduce the height of the offices and allow for additional insulation.

The loading on the roof is determined by the State Building Code. If this was a new construction, the roof would be designed for a snow load of 40 psf (the minimum snow load for new buildings). For existing buildings, snow load reductions are allowed to take advantage of the sliding snow effects due to a slippery roof surface and relatively steep pitch and can be reduced to about 25 psf. The standard 2x8 rafter has a live load capacity of about 10 psf- much less than the standard for new construction and less than half the capacity required for the reduced load. The 10 psf equates to about 6" of wet heavy snow.

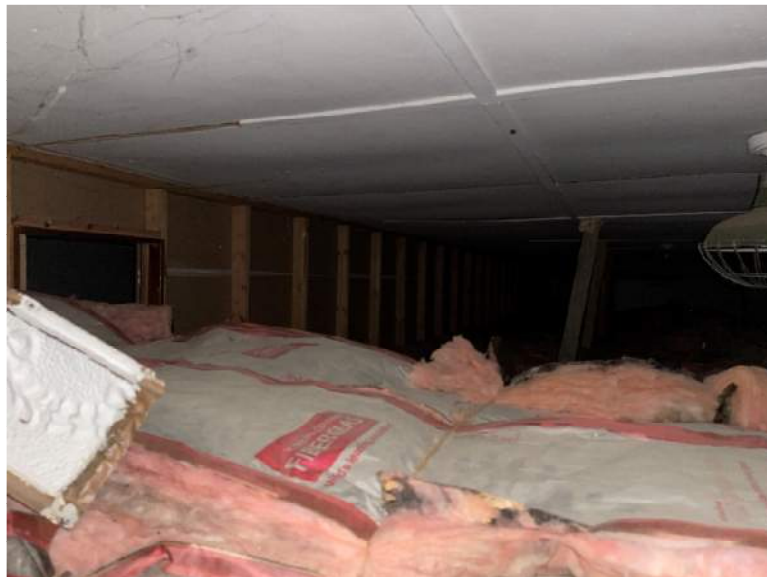
SOUTH SECTION CEILING ADDED BELOW ATTIC

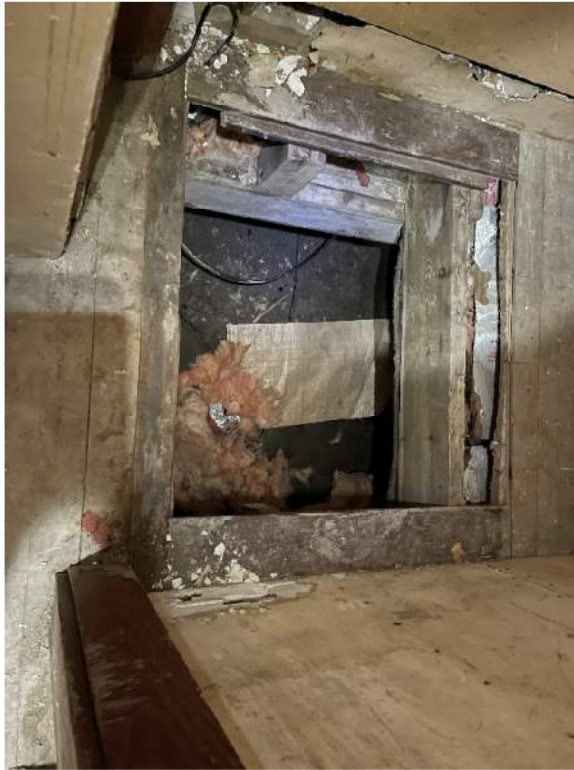
CRAWLSPACE ACCESS AT NORTH

- The floor joists at both access locations are 2x8 joists @ 16" oc
- At the north access, a 4-2x8 beam was measured about 8 feet from the north wall. In this area, the 8 foot span joists have a reasonable capacity but the beams have about 30 psf live load capacity.

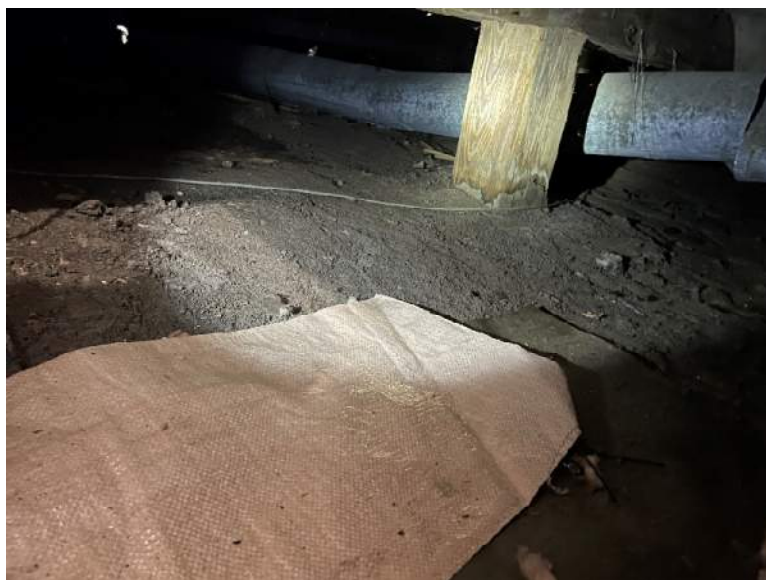
- The crawlspace is extremely damp with a soil floor less than 2 feet below the first floor. There is no vapor barrier on the crawlspace floor. This lack of moisture control has contributed to the high moisture content in the crawlspace.

- Access was limited so the condition of much of the framing could not be directly observed. However, the high moisture content and past presence of mold indicate that deterioration (rot) of portions of the framing is likely. Several access holes would need to be opened to assess more of the framing.

WATER STAINED POST IN CRAWLSPACE

- Adding a poly vapor barrier on the crawlspace floor.
  - Adding insulation and air sealing.
  - Waterproofing the outside walls.
  - Installation of electrical and mechanical equipment, if necessary.

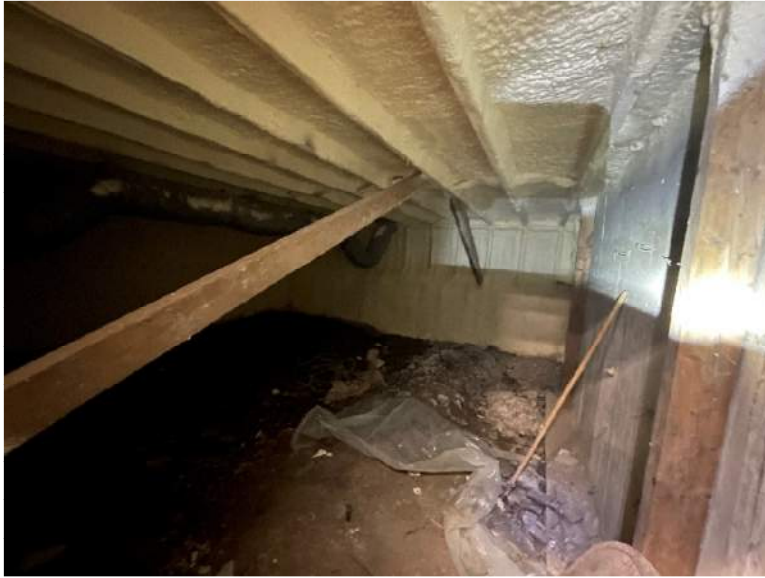
SOUTH CRAWLSPACE

- At the south access, the joists span about 14 feet and have a capacity of about 30 psf.
- There is a pattern of sagging along the length of the meeting room that suggests beams are spaced at varying dimensions from about 10 feet to 15 feet apart with a joist capacity of about 30 to 70 psf live load. The varying floor elevations suggest deflection or deterioration of the framing, or both.
